Project Site and Proposed Mine Phasing

**Existing Mine Conditions**

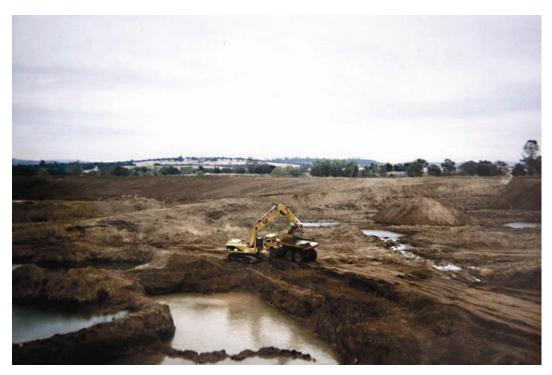
Mining in the existing operation. Mined material is loaded on haul trucks from an excavator transport to the processing area south of the Bear River. View to southeast.

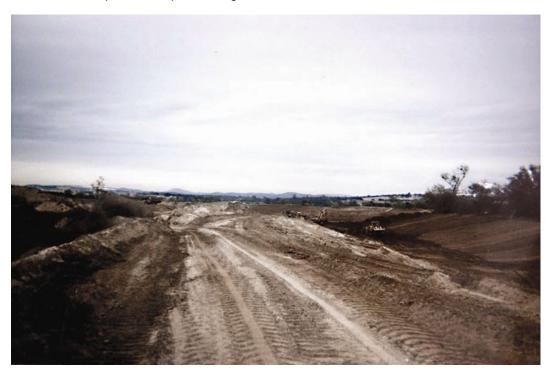
Initial pit development. After grading and clearing, excavators and dozers begin mining surface and near-surface materials. View to southwest.

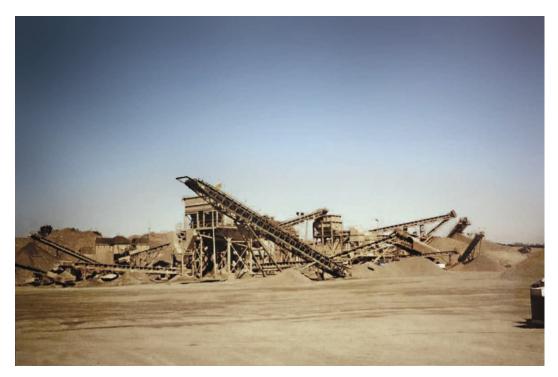
Existing processing facilities shown include Wash Plant No. 2 (including sand classifier) and crusher plant. View to east.

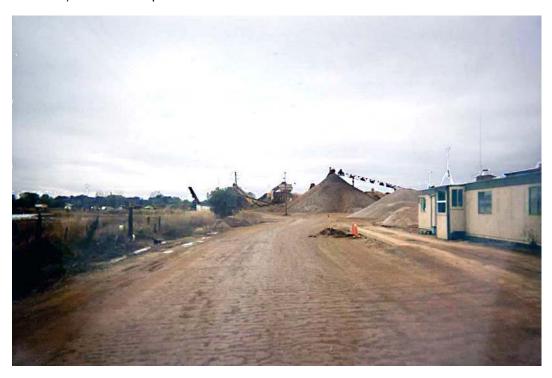
Scale house with crusher and stockpiles in the background. View to north.

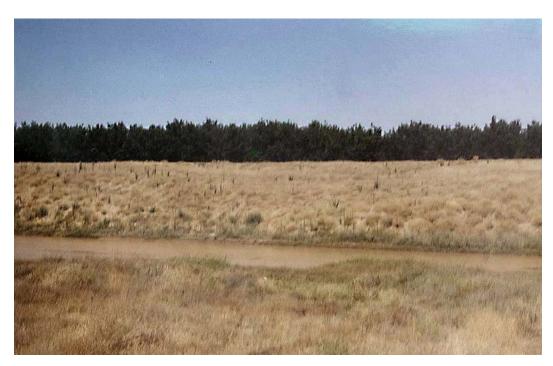
Reclamation of mined areas to open water and wetland habitat in the southeastern portion of the Patterson mine site. Wetland plant species established using natural recolonization and supplemental revegetation. View to southeast.

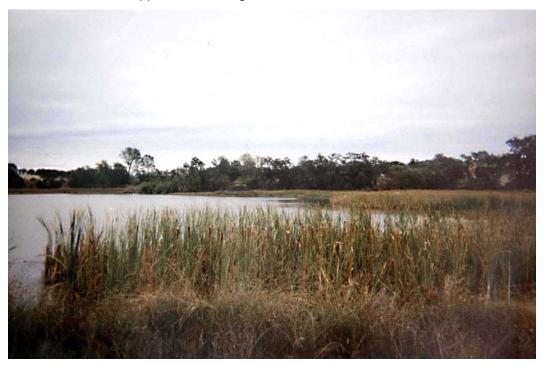
Revegetation of mine side slopes. Planted species include Valley Oak and several grass species. View to north.

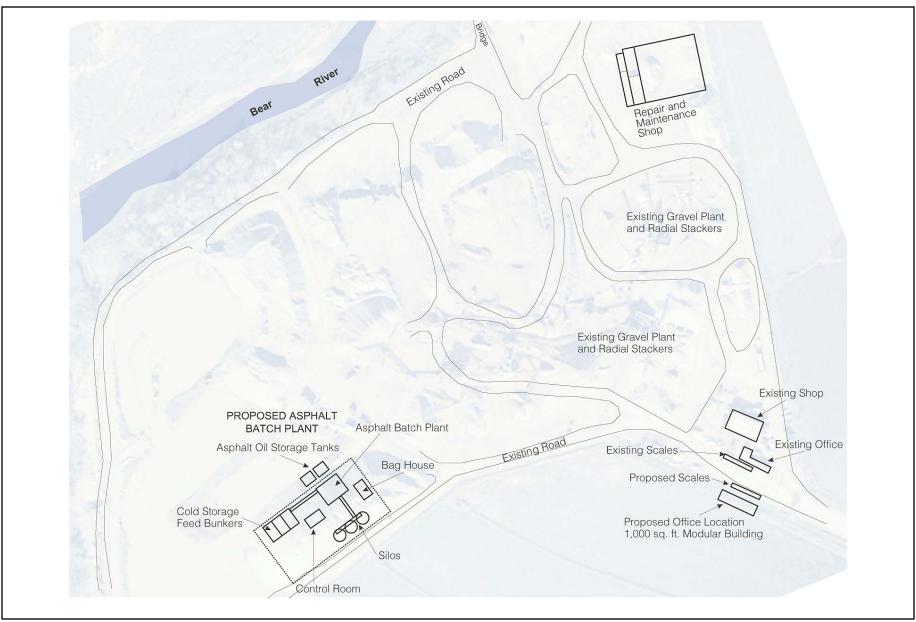
EXHIBIT 2-10

**Processing Facilities**

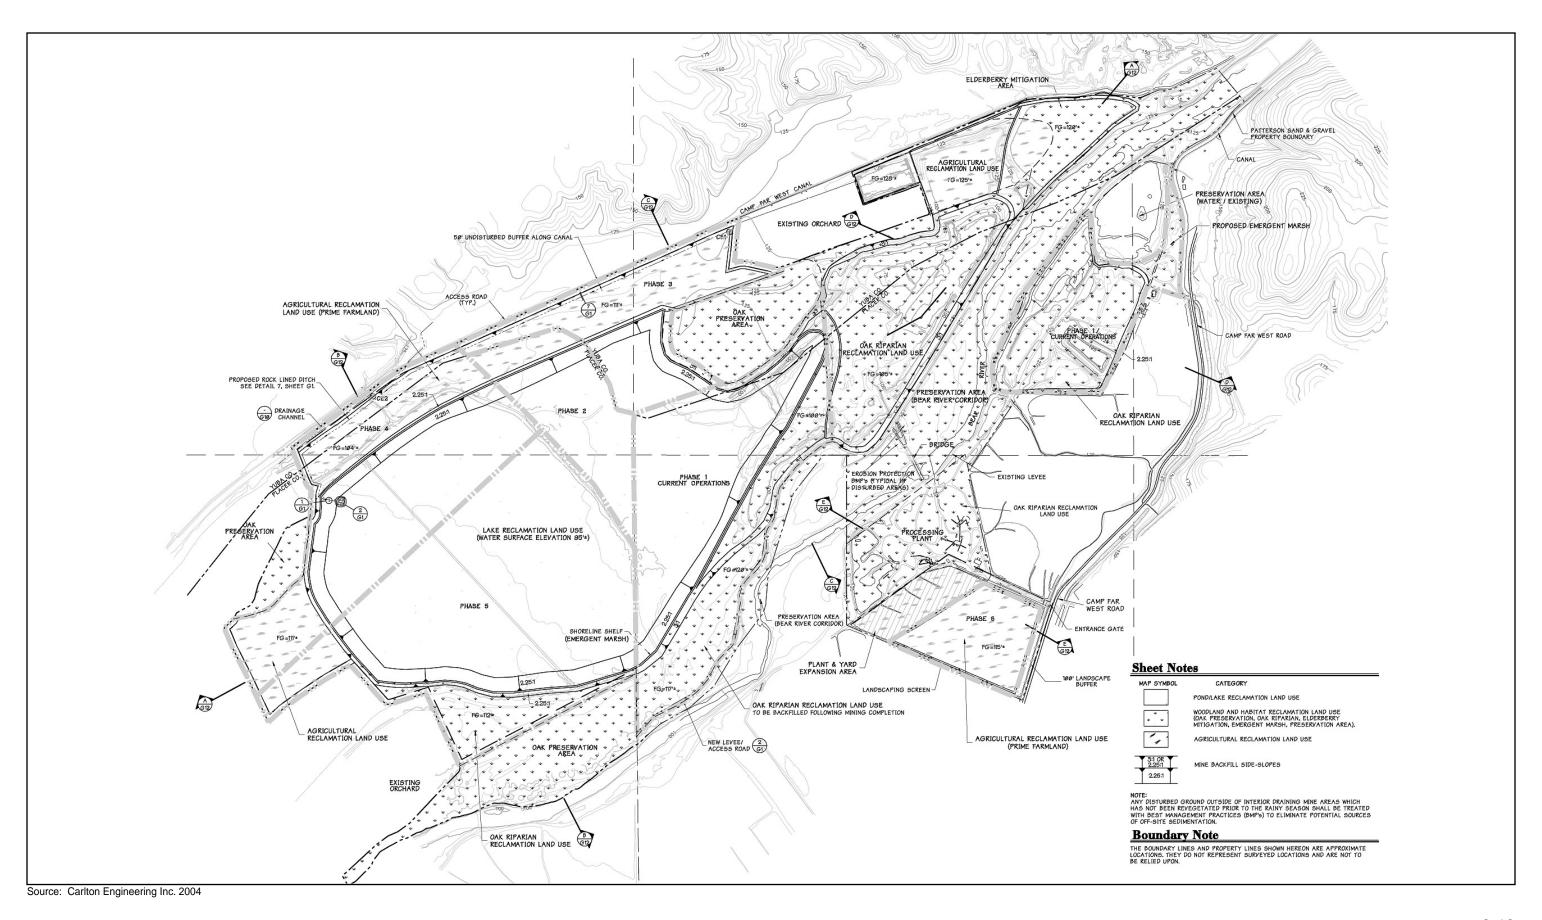
Proposed Reclamation Plan
